PROPERTY CONDITION ASSESSMENT
OF
WORLD TRADE CENTER PORTFOLIO

FOUR WORLD TRADE CENTER

FINAL DRAFT

Re: **Due Diligence Physical Condition Survey**
World Trade Center
New York, New York

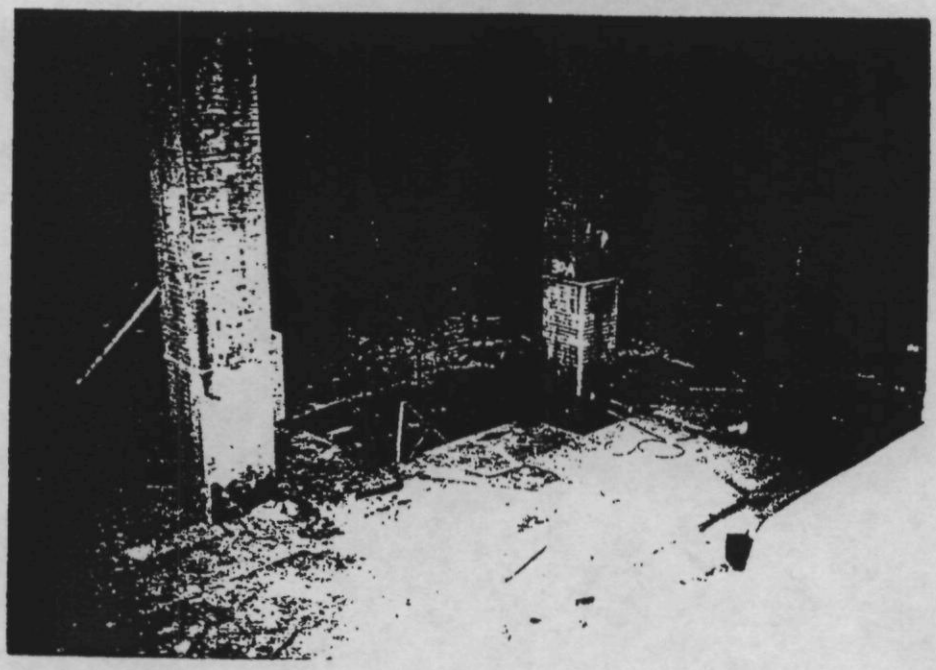
Photograph 1

Entrance pylon at Church Street Plaza entry

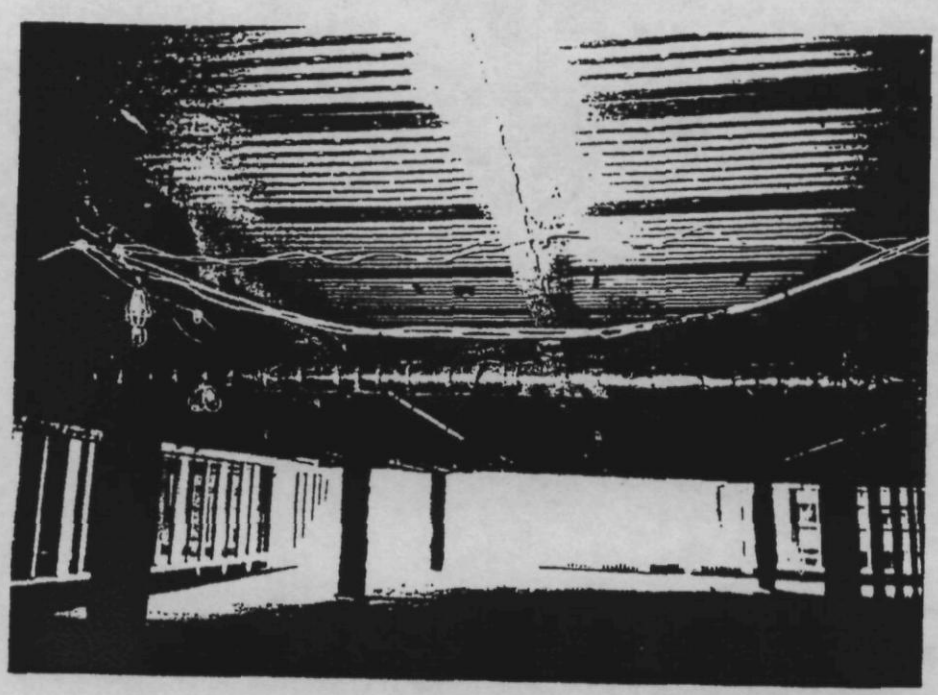
Photograph 2

Existing structure below building at B-2 level remaining from PATH station

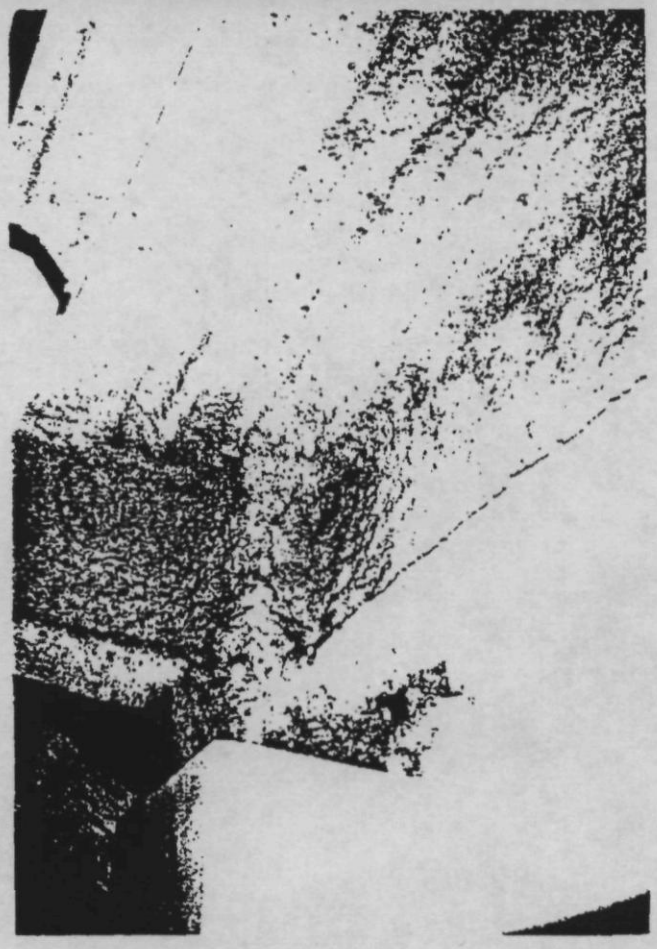
Photograph 3

Typical building structure with 30' column bays, cantilever at perimeter, steel framing and metal deck

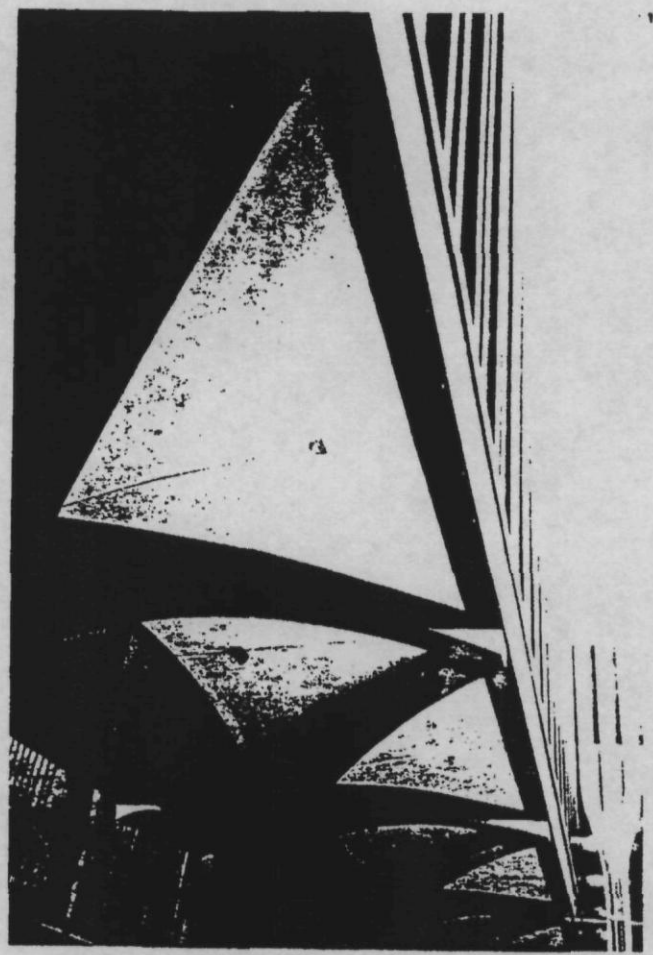
Photograph 6

Framing of cantilever below 4th floor deck

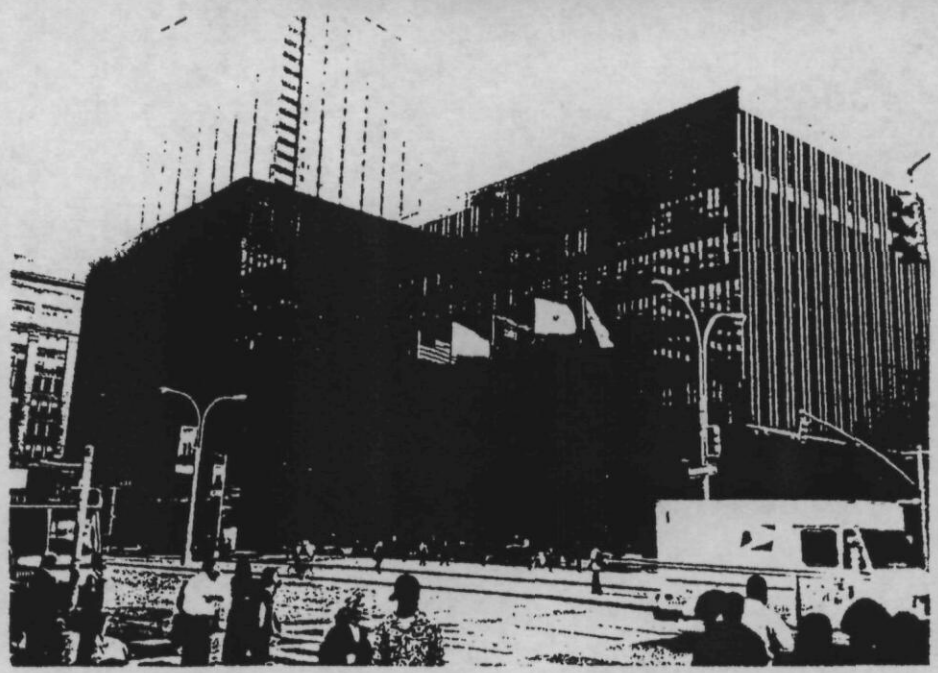
Photograph 7

Aluminum cladding conceals steel truss to support cantilever at 4th floor overhang

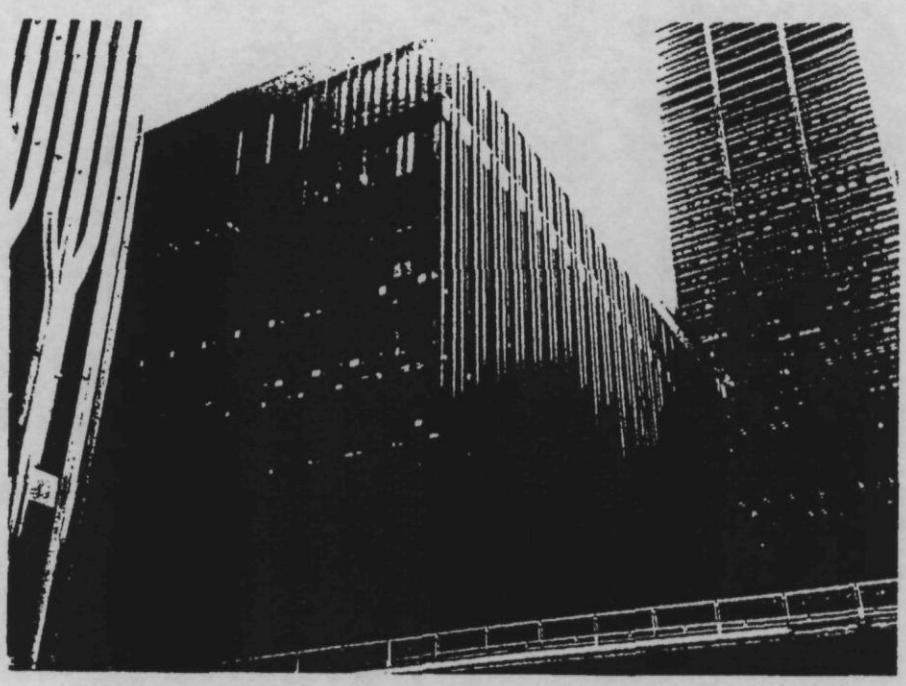
Photograph 10

Supplementary stair tower added in 1995-96 to serve trading room on 8th floor

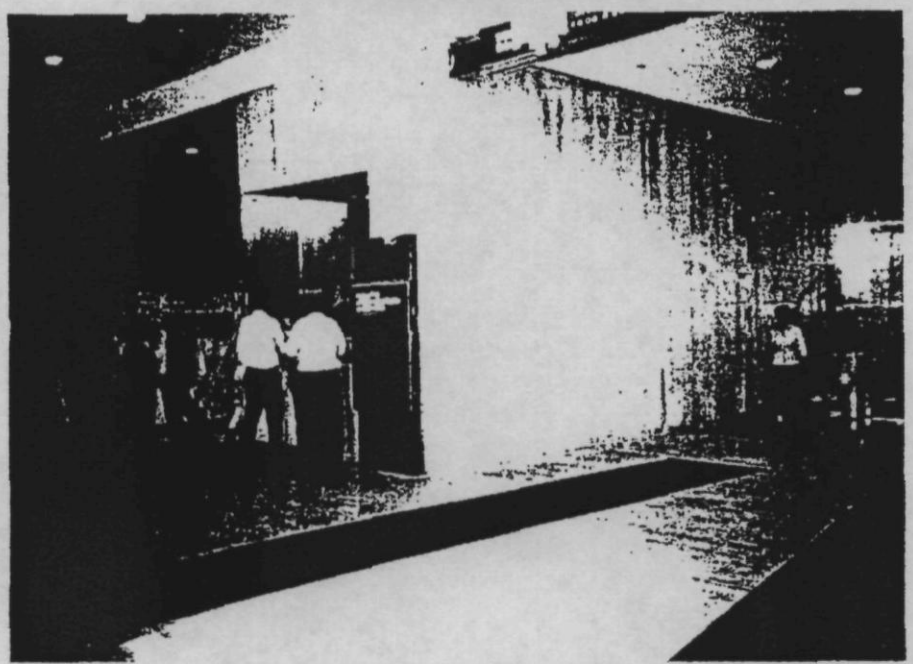
Photograph 17

Concourse level elevator lobby

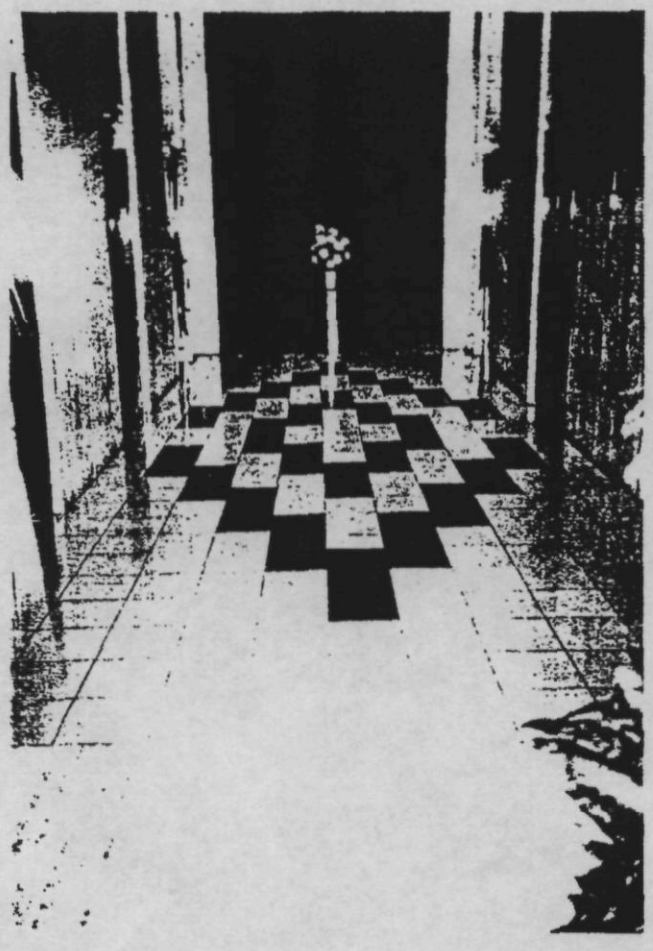
Photograph 18

Main entrance at Plaza level from Church Street. Escalator at right connects to Concourse level

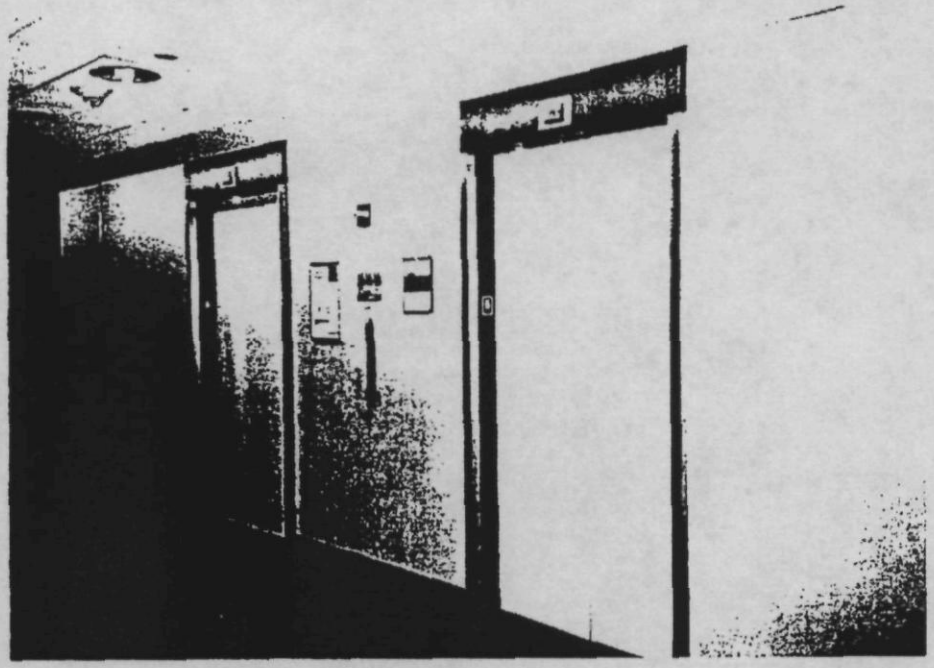
Photograph 19

Plaza level elevator lobby

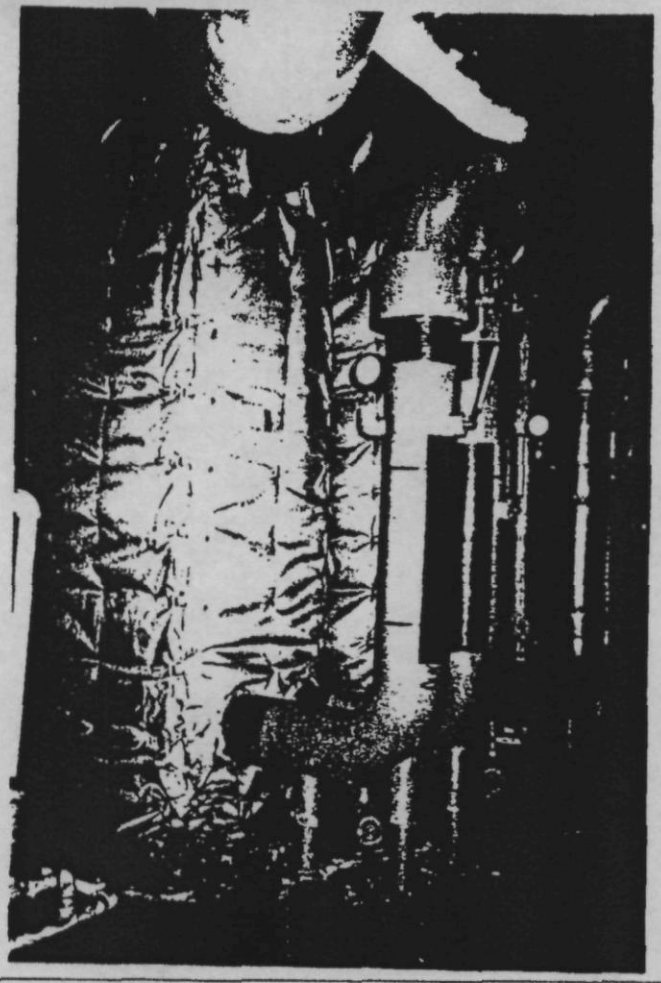
Photograph M3

Chilled water pumps located in the B1 mechanical room

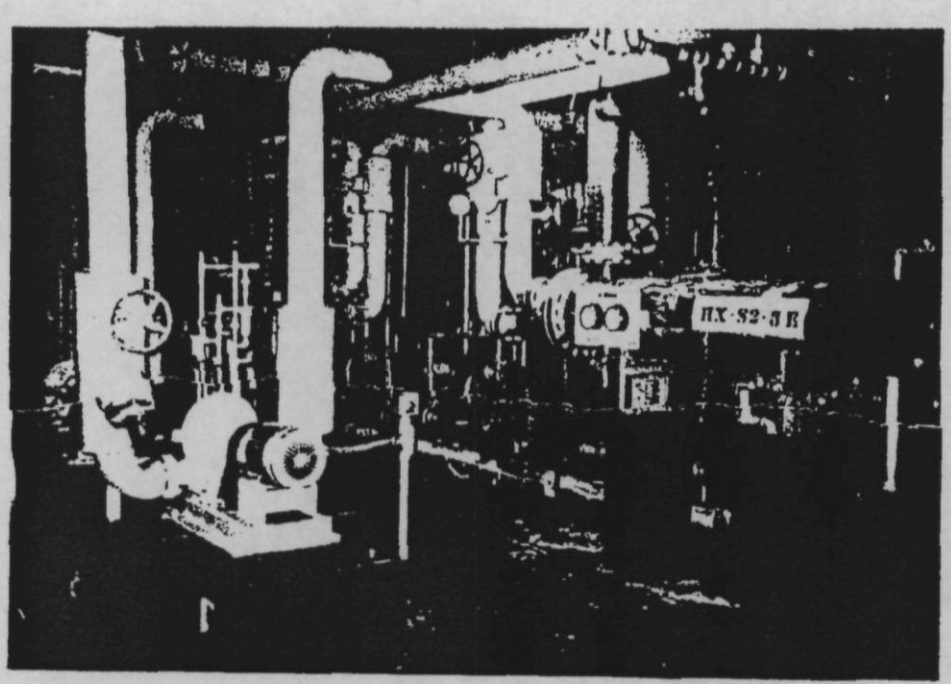
Photograph M5

Condenser water supply and return lines for tenant supplementary air conditioning

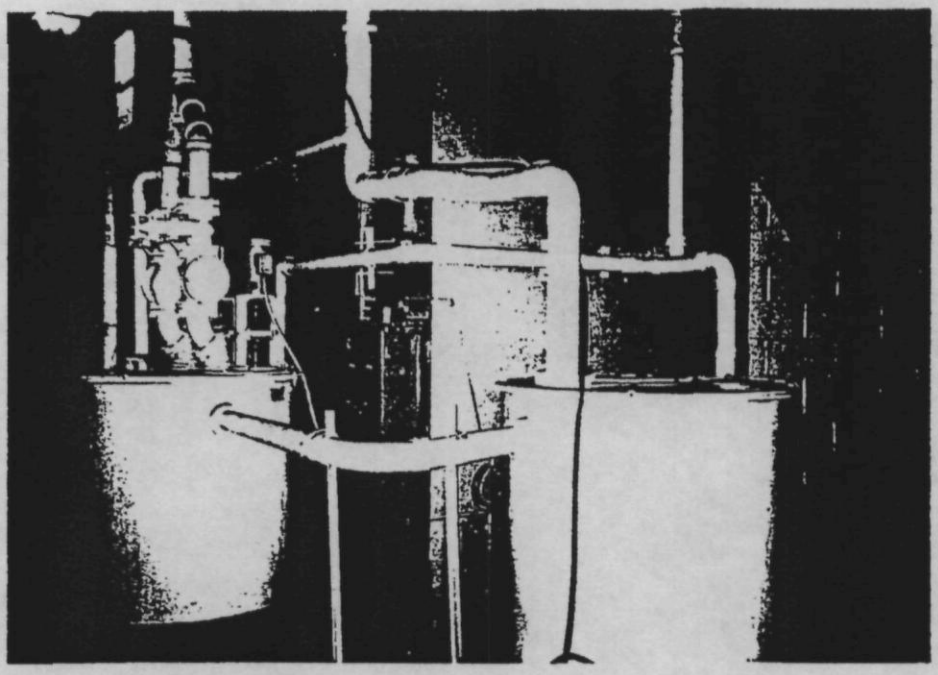
Photograph M6

Heat exchanger and circulating pump for heating hot water

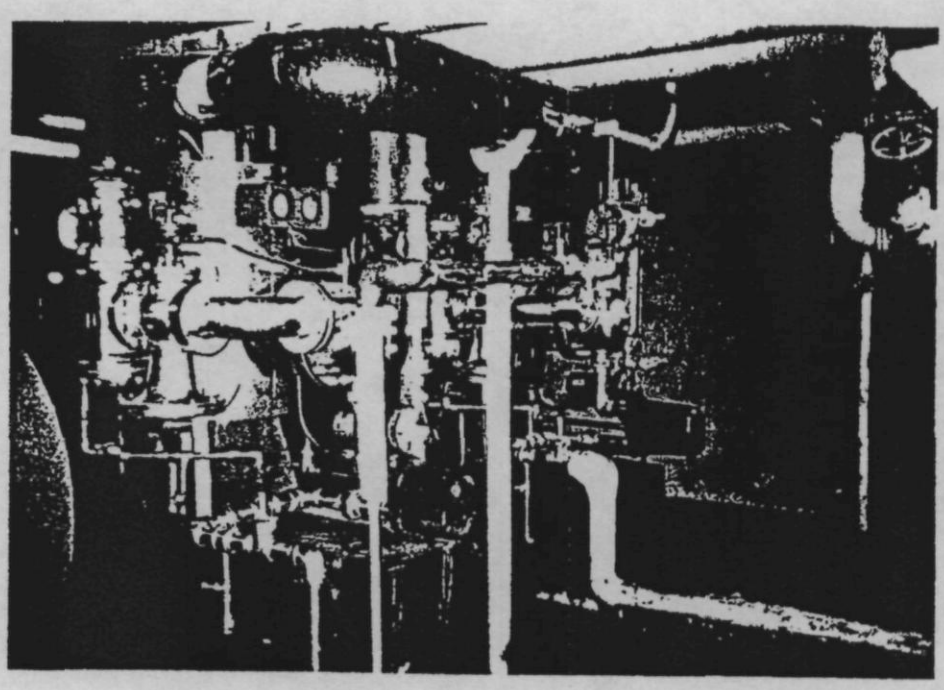
Photograph M7

Ejectors and tanks located in the B1 mechanical room
